## **HISTORIC DISTRICT COMMISSION MEETING AGENDA**

1. **COA #25-0177 Beaulieu Hardware Building**

## ROGERS HISTORIC DISTRICT COMMISSION MINUTES: May 6, 2025

## COA: OZ Smokehouse

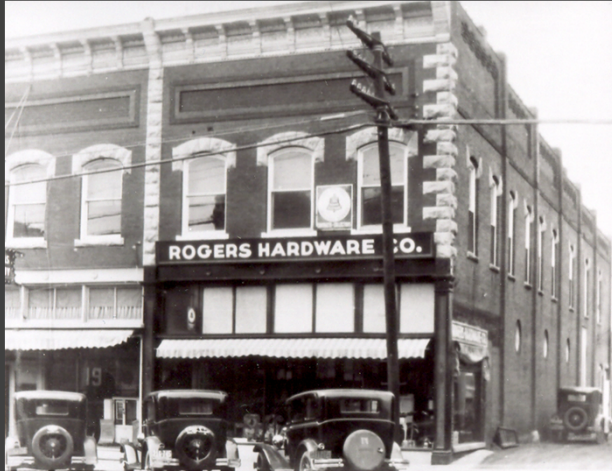
*Historic Photo*

This is a photo taken in the early 1900's of Rogers Hardware.

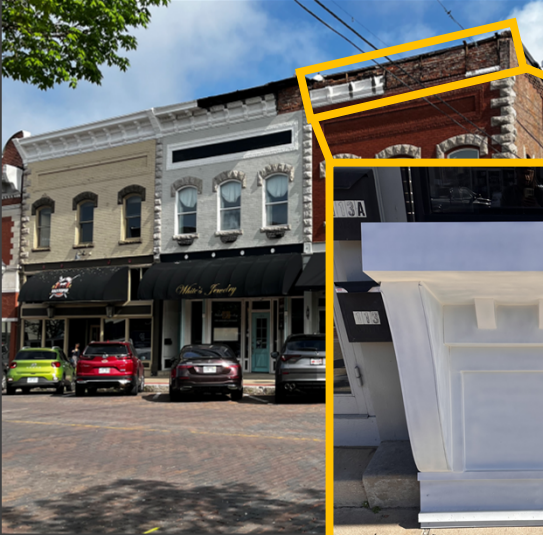
*Current Conditions*

- May 2024 tornado damaged the cornice
- The damage is also observed on the two adjacent store fronts that were constructed at the same time
- Current cornice is an intricate stamped metal visible on all three buildings
- Proposed cornice has a simpler appearance and would be different from the two adjacent buildings

The cornice was damaged during the May 2024 tornado on the subject property as well as the adjacent buildings. The proposed cornice is simpler in appearance compared to the intricate stamped metal visible on all three buildings.

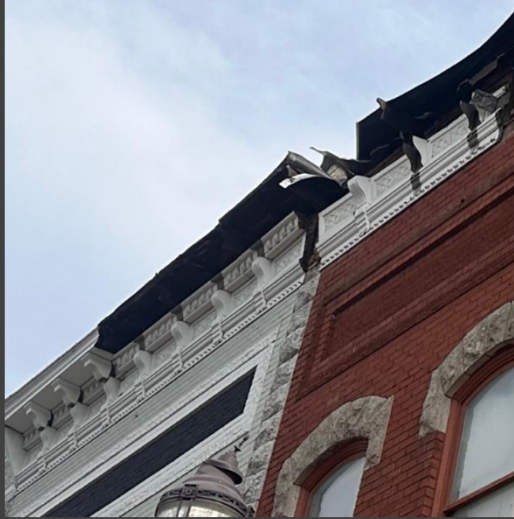
*Close up of Cornice*

- 6.10 (Cornices):
  - A) Most historic commercial buildings have cornices to cap their facades. Their repetition along the street contributes to the visual continuity on the block. They may be straight or stepped parapet.
- The proposed cornice would break the visual continuity on the buildings

The design guidelines state that cornices repeat and it visually connects the block. The proposed cornice would break that visual continuity on these three buildings.

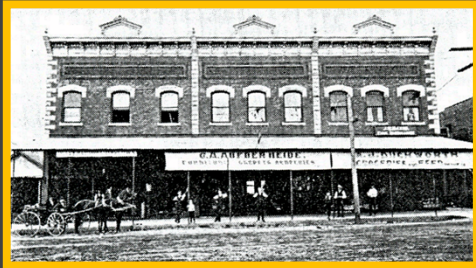
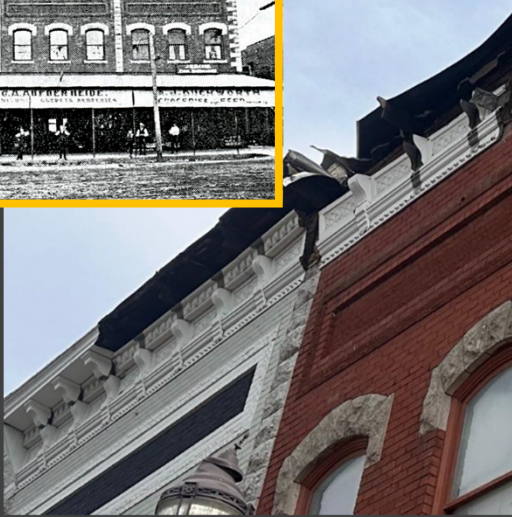
*Close up of Cornice*

- 6.10 (Cornices):
  - B) Cornices that are intact should be preserved. Reconstruct a missing cornice is preferred when historic evidence of its character is available. Use historic photographs, if available, to determine design details of the original cornice.
- There is historical and current evidence of the original stamped metal cornice design.

The guidelines also state that if the cornice is intact or historical evidence exists then the character of the cornice should be preserved. From both the historical photo and current photo, the original stamped metal cornice is visible.

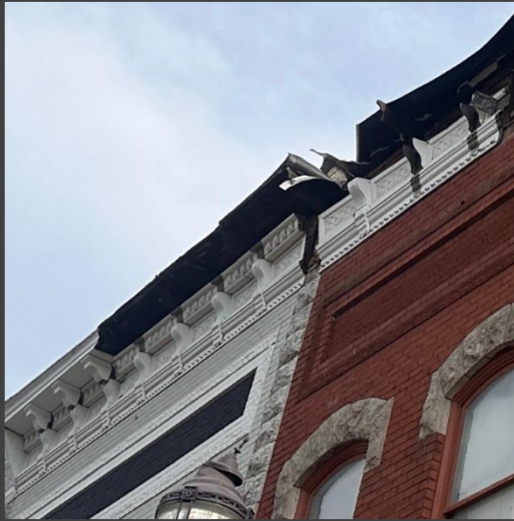
*Close up of Cornice*

- 6.10 (Cornices):
  - C) Substitution of another old cornice for the original may be considered, provided the substitute is similar to the original.
- The proposed cornice is not similar to the original design that is still attached to the buildings.
- Arkansas Historic Preservation Program strongly recommends a closer match to the original cornice.

The guidelines state the cornice should appear similar to the original. The Arkansas Historic Preservation Program strongly recommends that a closer match to the original cornice be sought. Although, the National Register Coordinator believed the proposed cornice would likely not result in the building losing its contributing status or state and federal historic tax credits as well as AHPP grants.

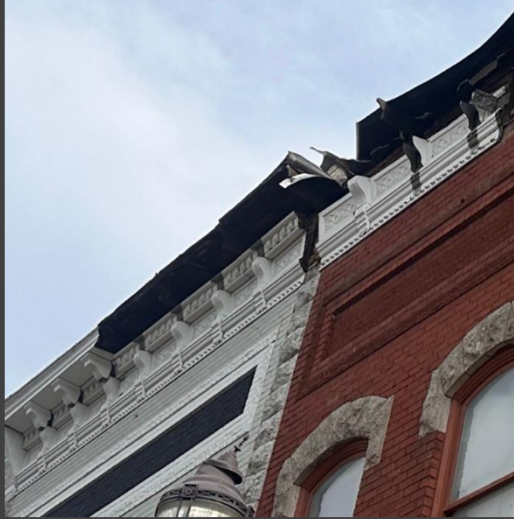
*Close up of Cornice*

- 6.10 (Cornices):
  - D) *"If it is not possible to find photographs or evidence of the original cornice, a simplified interpretation is appropriate. Materials for reconstructed cornices include stone, brick, and stamped metal."*
- Because we have both historical and current evidence of the original appearance, the design of the stamped metal should be replicated to repair the cornice on the building.

Due to the historical and current evidence of the original appearance , the design should be consistent with the current cornice.
